Horizon Inspections, LLC

Home Inspection Report

123 Anywhere St, Your City, AZ 85641
Inspection prepared for: John & Jane Doe
Date of Inspection: 5/15/2019 Time: 9:00 AM
Age of Home: 2006 Size: ~1,808 sqft
Weather: 52* F, Sunny, No Recent Rain
It was our pleasure to serve you!

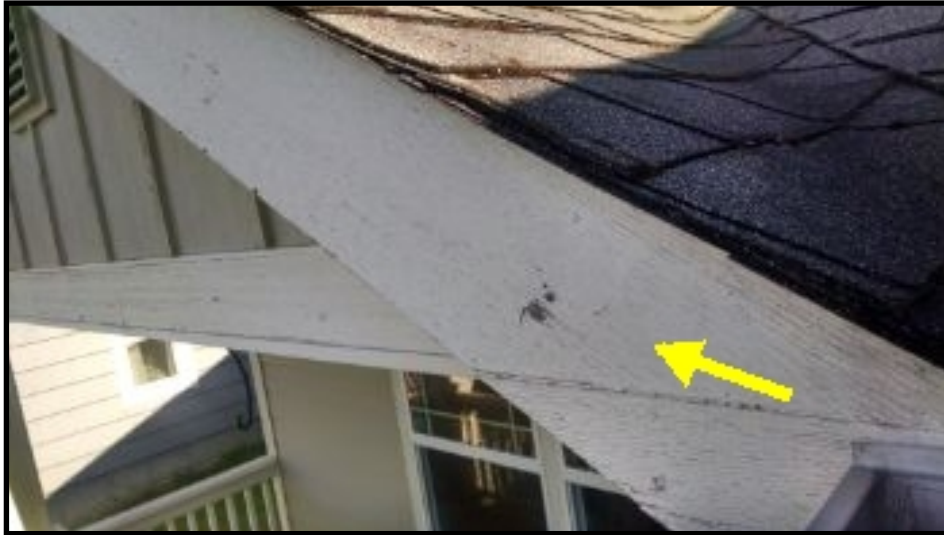
5. Exterior Paint

- MAINTENANCE:
- Peeling, flaking paint observed at some of the trim areas especially at or above roof level. The trim appeared to be overdue for exterior paint. We recommend scraping and painting as needed.

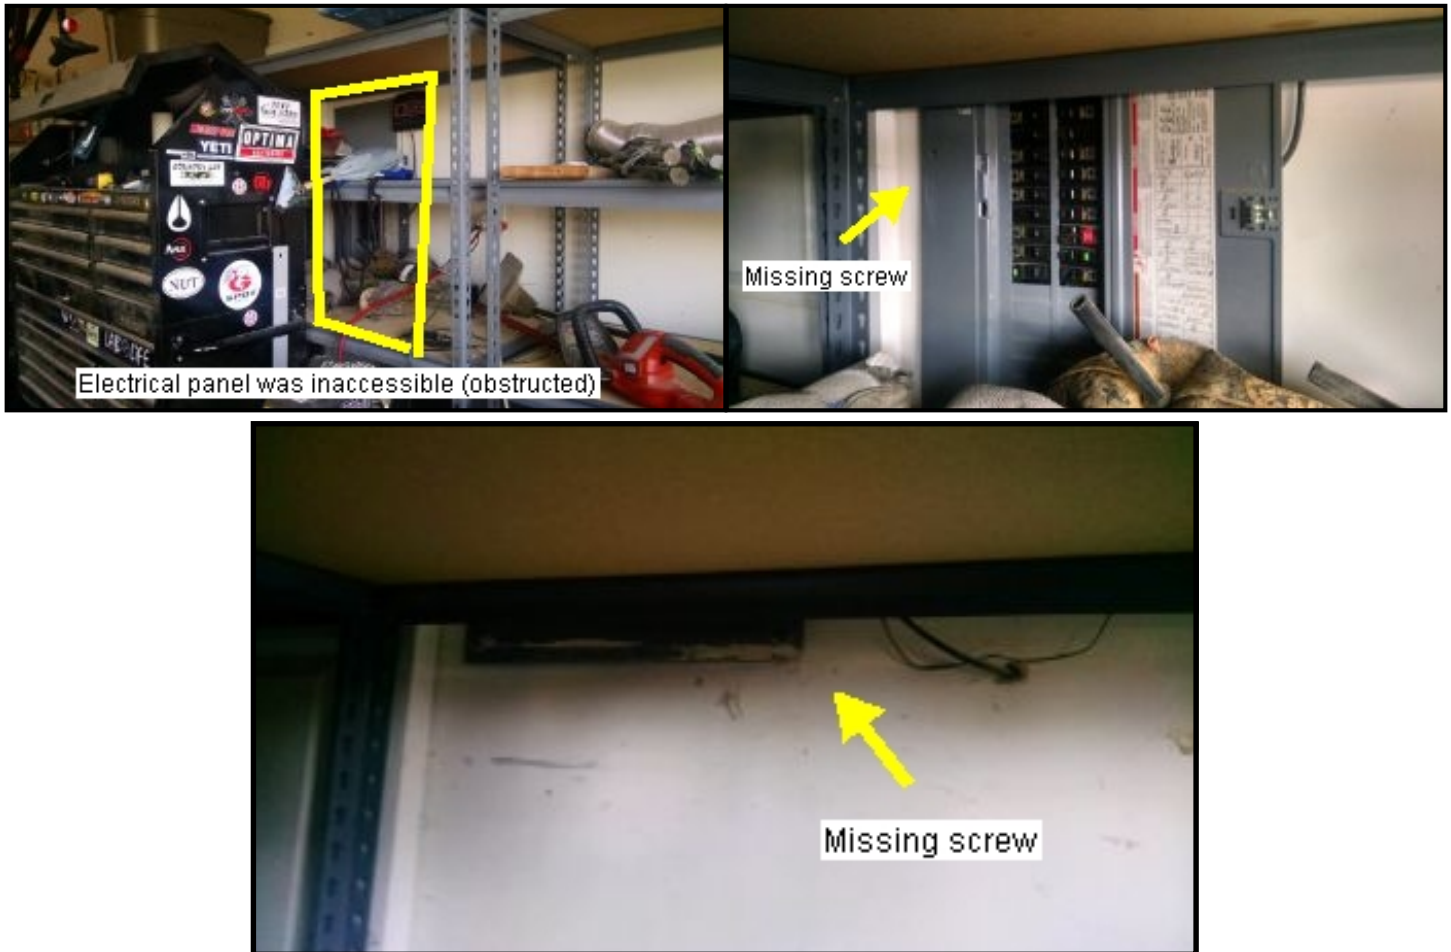
- Panel cover screw(s) missing. We recommend replacing with proper flat-tipped screws.

- Limited review. The interior of the electrical panel was not evaluated due to obstruction by a large volume of stored items. We recommend having the items moved so that the panel interior can be inspected prior to closing.

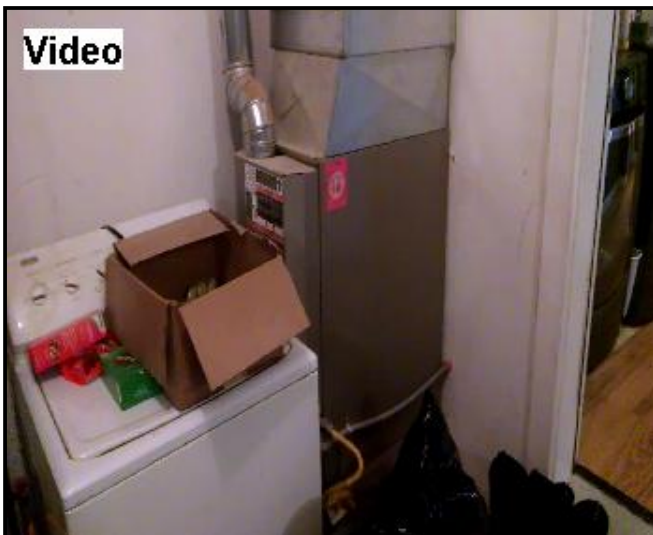
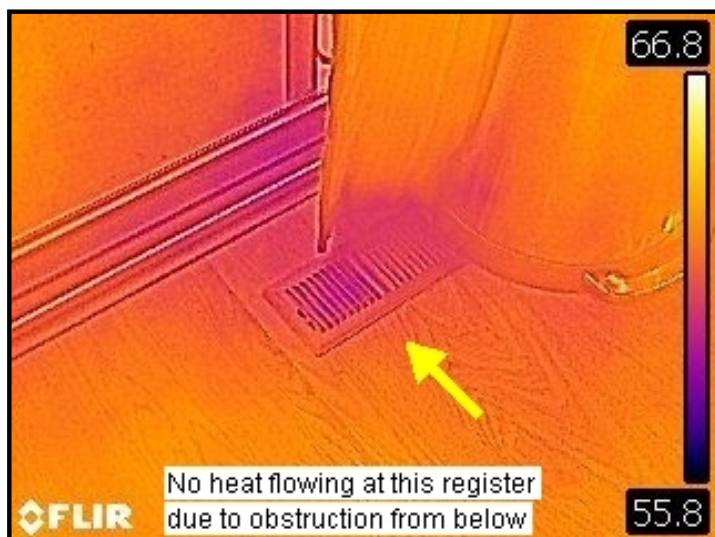
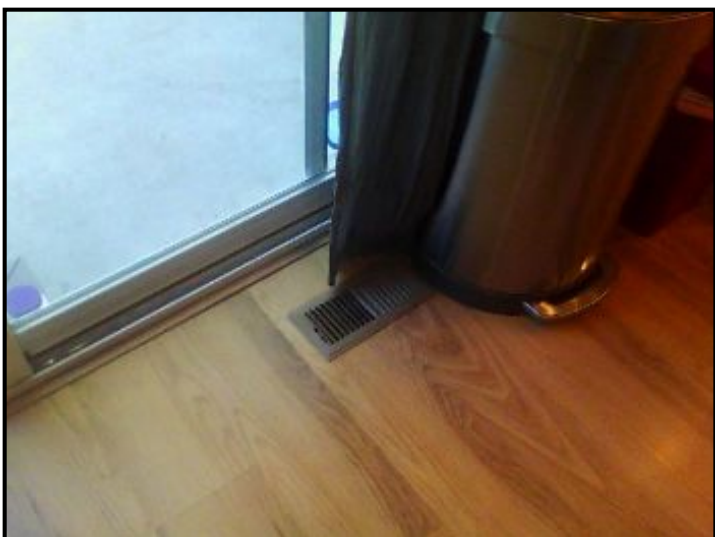
1. Heater Condition

• **SAFETY CONCERN; REPAIR/REPLACE:**

• The gas furnace was inaccessible due to obstruction by a large volume of stored items. The last service date was unable to be determined. During operational testing, the unit was unusually noisy and showed evidence of chronic condensation build-up inside the subfloor ducts which was obstructing air flow to at least one floor register. This indicates serious internal problems such as a cracked heat exchanger or other defect. During the life span of any furnace, the metal walls of the heat exchanger may develop a crack or a broken weld, allowing carbon monoxide and moisture-laden exhaust air to circulate throughout the home. If this moisture-laden air condenses inside the ducts it can turn to liquid and obstruct airflow as seemed to be the case here. There was no air flow at one of the heat registers (see photos and videos). This is a high priority concern and should be followed-up by a licensed HVAC technician for repair or replacement as needed. Be advised that if the heat exchanger has failed, the only reliable cure is replacement of the furnace.

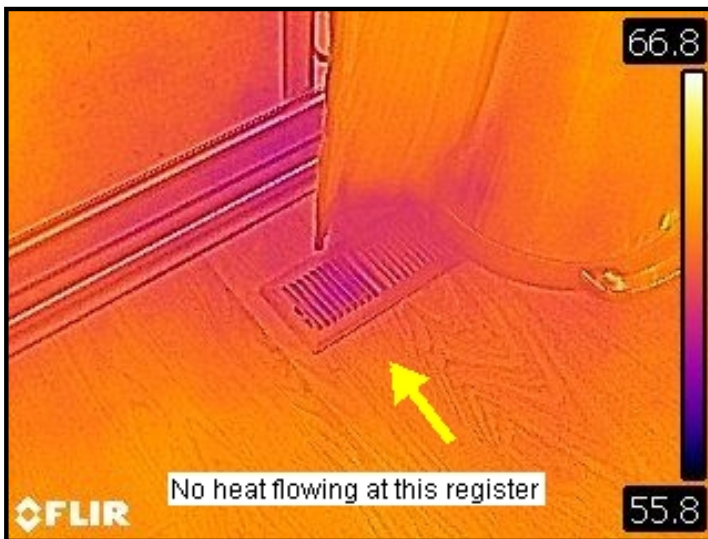
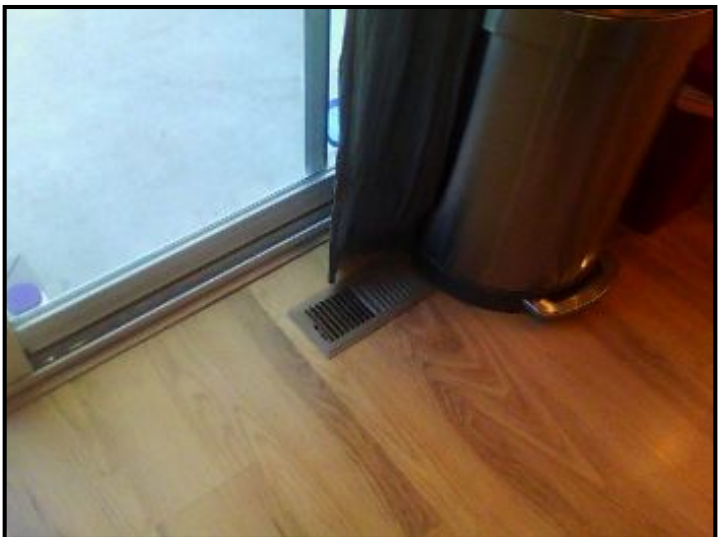
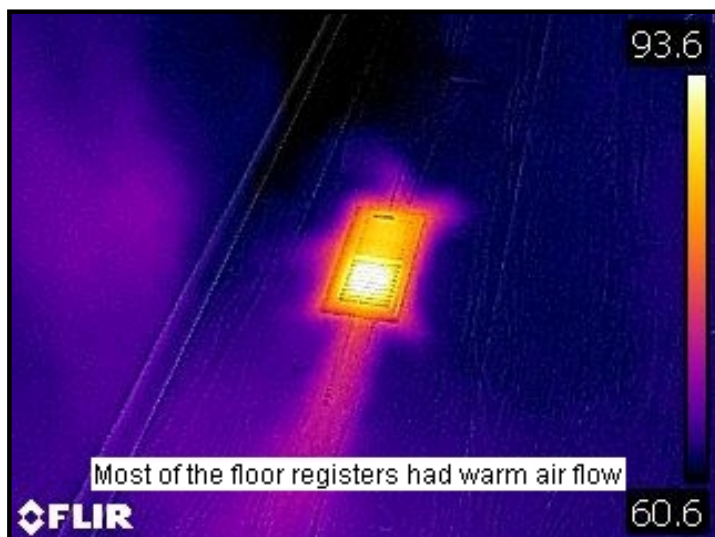
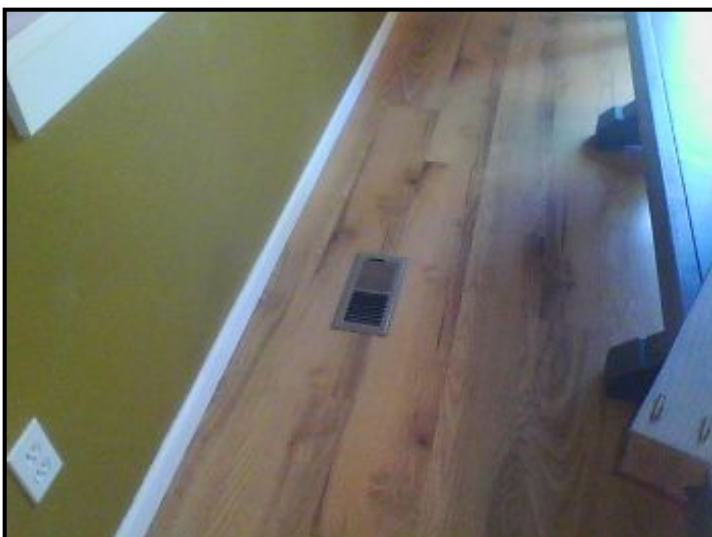
- SATISFACTORY:
- The return air and supply system appears to be functional except as noted below (See Heat/AC: Heater Condition for more)
- FURTHER EVALUATION:
- No air flow present at the register closest to the sliding patio door. Air flow appeared to be obstructed by a large volume of water trapped inside the duct. We recommend further evaluation by a licensed HVAC technician for repair and to restore proper function.

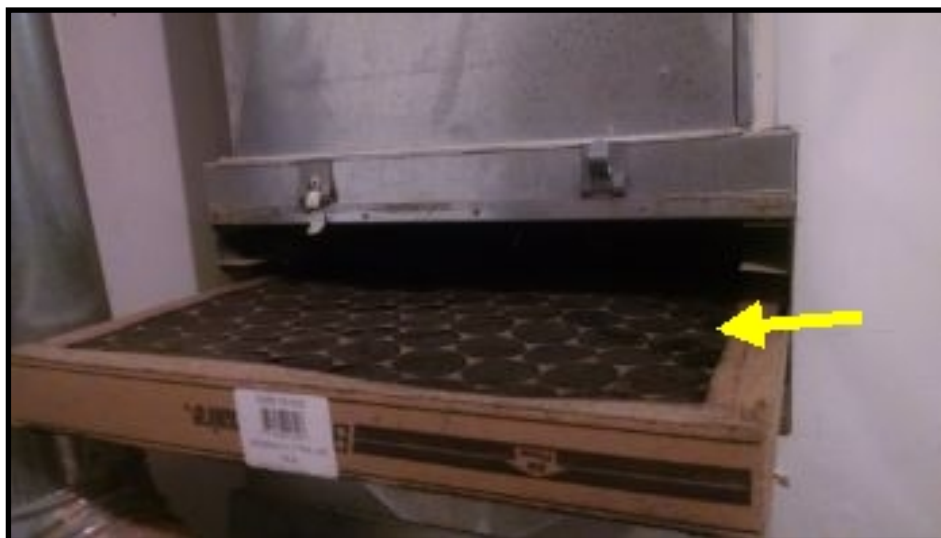
• Furnace filter appeared to be dirty. We recommend replacement (easy, low-cost repair).

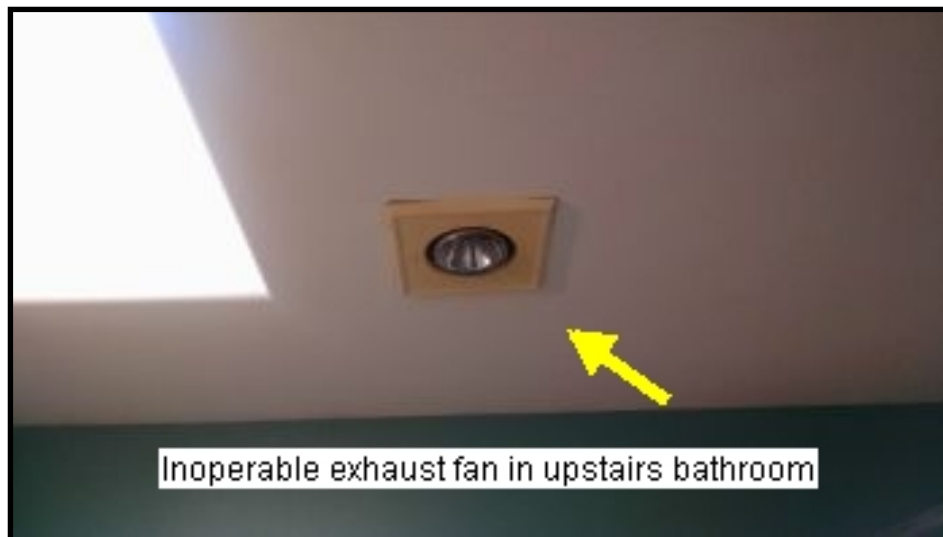
- SATISFACTORY:
- The bath fans were operated and appeared functional except where noted.
- **REPAIR/REPLACE:**
- Exhaust fan was inoperable at the upstairs bathroom. We recommend repair or replacement as needed.

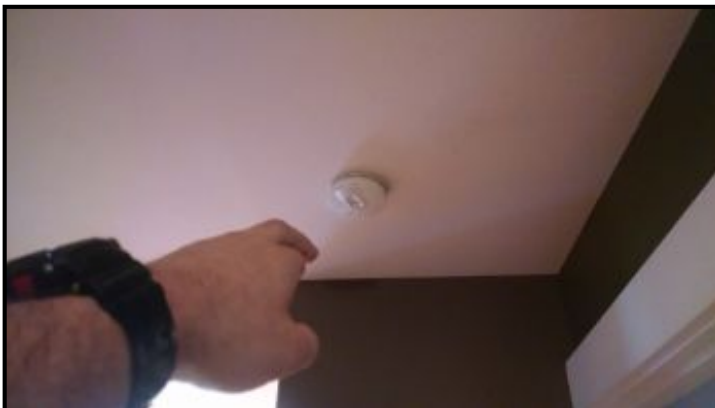
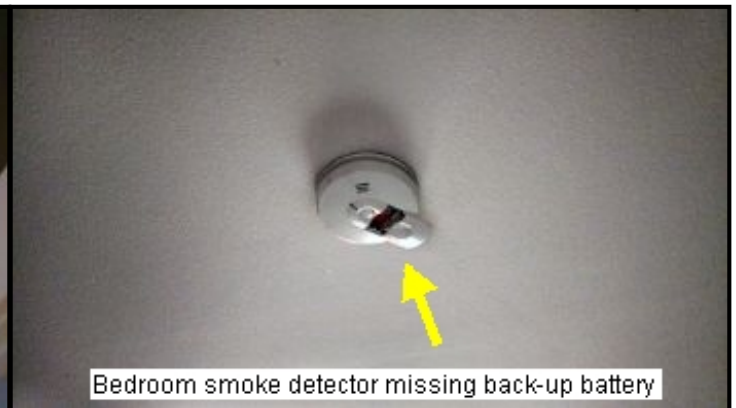
• There was no visible CO (Carbon Monoxide) detector installed in the home. We recommend installing prior to closing in compliance with local laws (RCW 19.27.530 & WAC 246-359-550). CO detectors are required to be installed in the immediate vicinity outside each sleeping area with a minimum of one on each habitable level of the home.

Bedroom smoke detector missing back-up battery

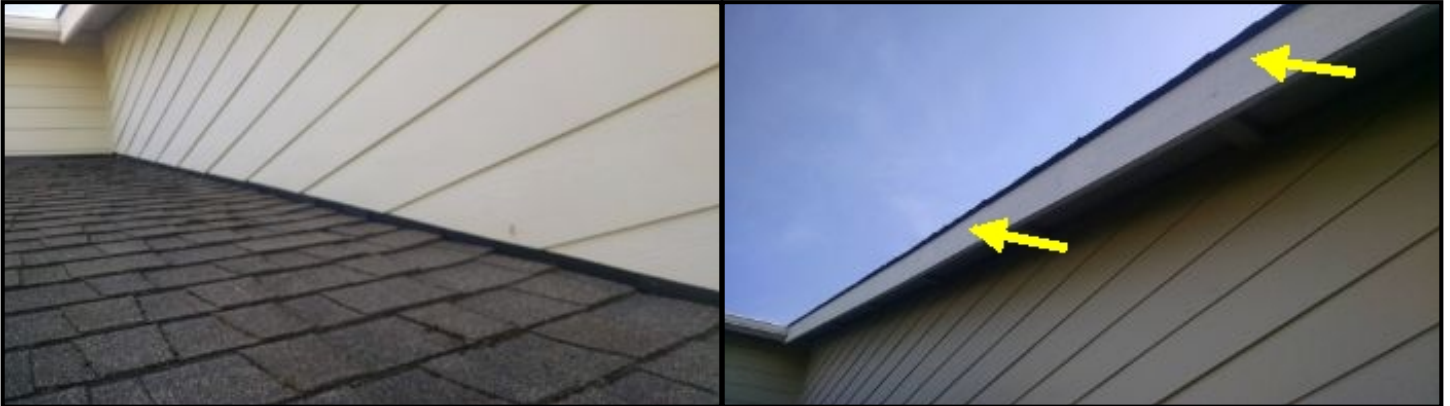
- It appeared there were no **drip edge** flashings installed at the rake boards. There did not appear to be any adverse affects from their absence (not required in all jurisdictions). We recommend monitoring for performance and installing drip edge flashings where missing.

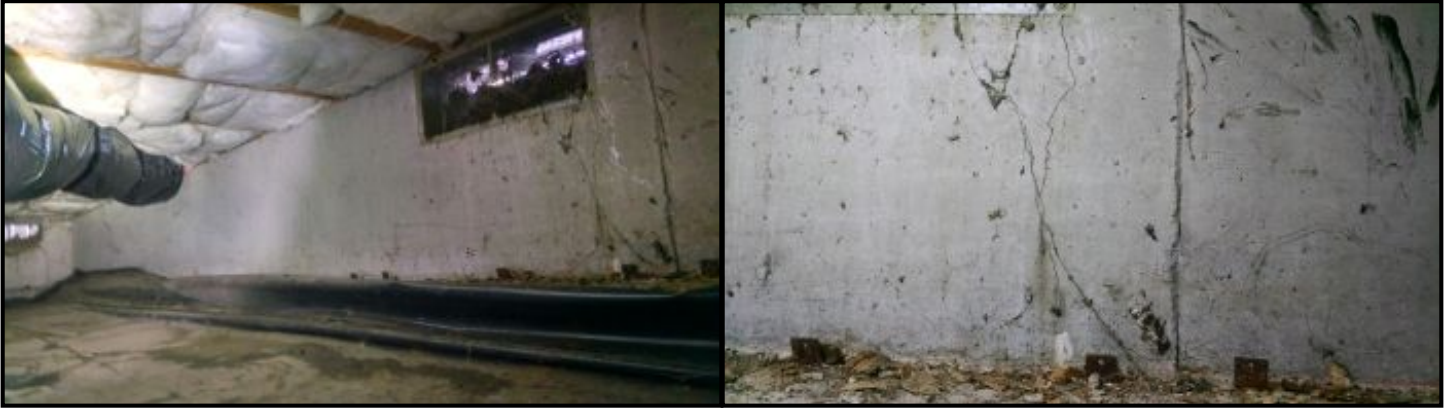
- Foundation walls noted as functionally adequate with normal settlement.
- Cracks (1/4" or less) present in foundation exterior wall. We recommend sealing them to prevent water infiltration. Generally speaking, cracks that are less than 1/4" are not commonly regarded as being structurally significant.
