Horizon Inspections, LLC

Home Inspection Report

123 Anywhere St, Your City, AZ 85641
Inspection prepared for: John & Jane Doe
Date of Inspection: 5/15/2019 Time: 9:00 AM
Age of Home: 2006 Size: ~1,808 sqft
Weather: 52* F, Sunny, No Recent Rain
It was our pleasure to serve you!

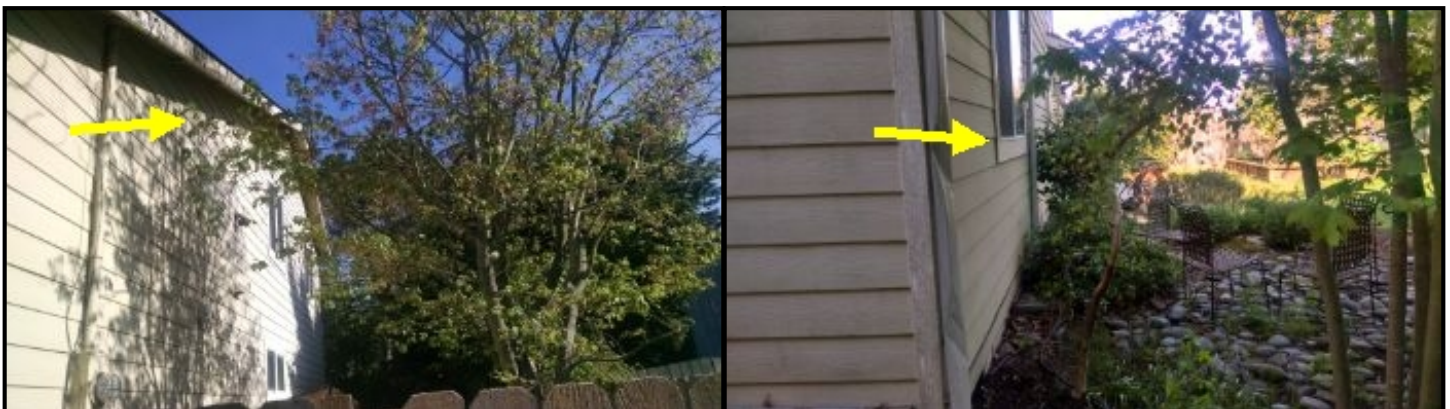
- **Maintenance Tip:** When landscaping, keep plants, even at full growth, at least 18 - 24" from the siding, windows, and roof. Plants in direct contact or very close proximity to home can provide pathways for wood destroying insects, as well as abrade and damage siding, screens and roof coverings.
- MAINTENANCE:
- Mild vegetation contact noted in some areas. Overall, vegetation is well-trimmed off the structure and not a concern. We recommend cutting trees and shrubs back 18"-24" to prevent moisture from being trapped against the siding and denying wood destroying insects easier access to the structure.

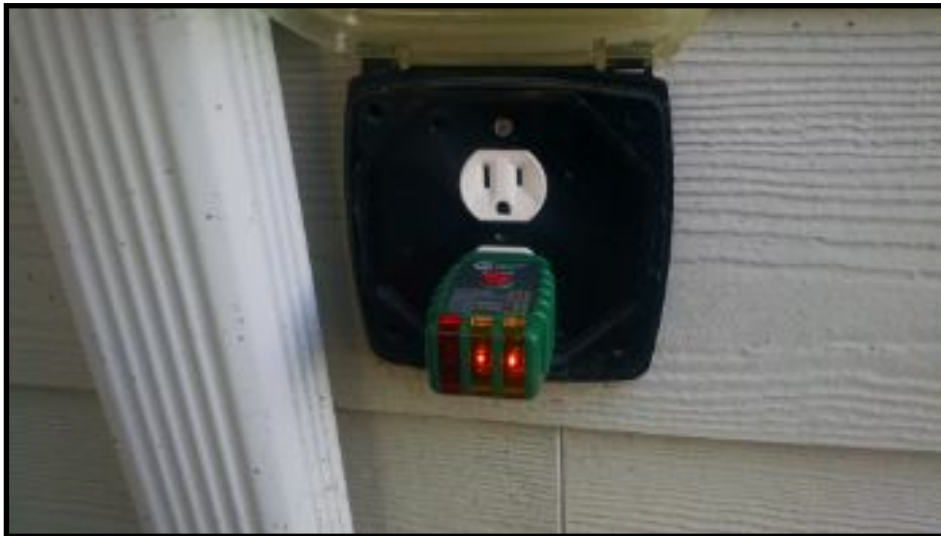
- Visual confirmation of a Grounding Electrode Conductor (GEC) being properly bonded to a Grounding Electrode (GE) with most modern homes isn't possible. Most homes built after 2005 and nearly all homes built after 2013 typically have an "Ufer Ground" - or a grounding system built into the metal rebar of the foundation itself (not visible). The electrical system behaved as if it were properly grounded by modern standards.
- SATISFACTORY:
- No major system safety or functional concerns noted at time of inspection.
- **OUTLETS**
- SATISFACTORY:
- Outlets appeared functional. A representative number of outlets were tested and showed correct polarity.

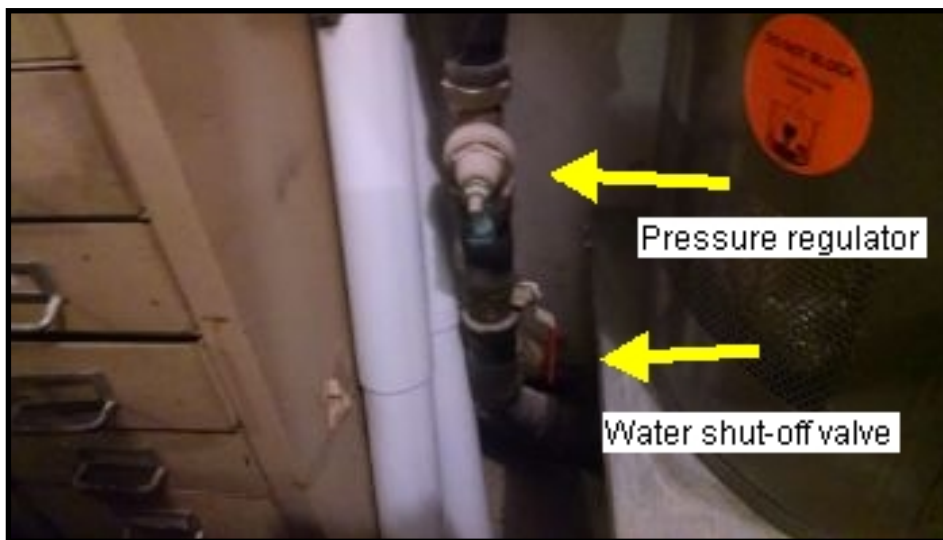
- See photo for main water shut off valve location. <FYI> Future reference in the event of an emergency.
- SATISFACTORY:
- Pressure regulator noted next to the water main shut-off valve in the garage (see photos).

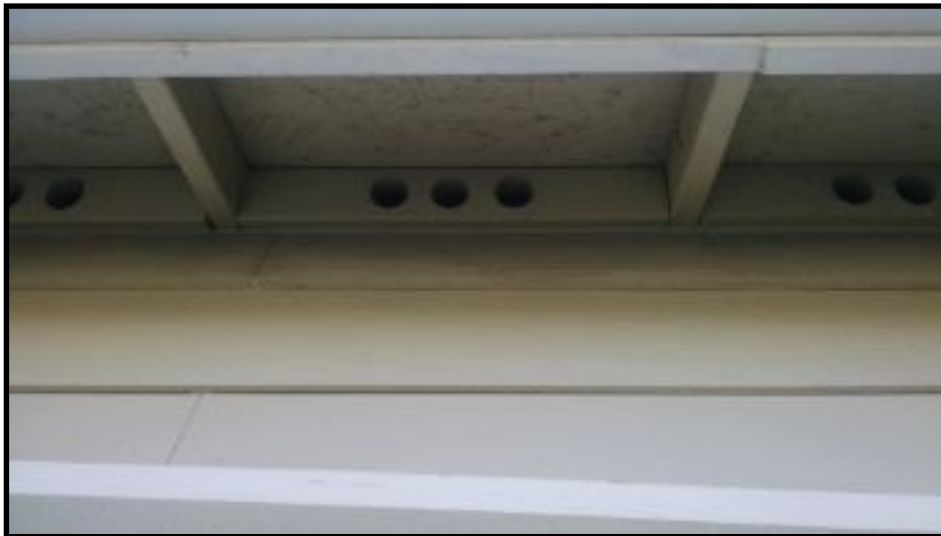
- SATISFACTORY:
- Eaves and soffits at the home appeared to be in serviceable condition at the time of the inspection.

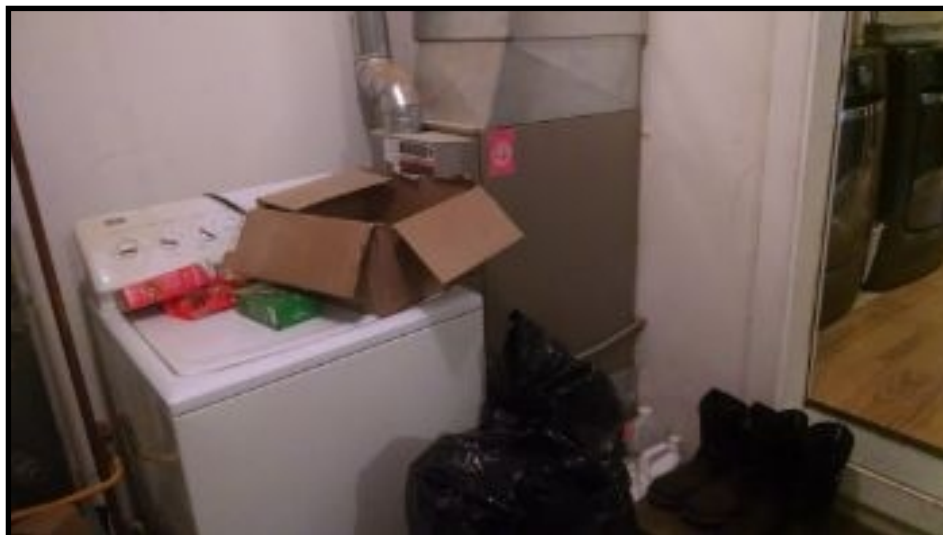
• The gas furnace was inaccessible due to obstruction by a large volume of stored items. The last service date was unable to be determined. During operational testing, the unit was unusually noisy and showed evidence of chronic condensation build-up inside the subfloor ducts which was obstructing air flow to at least one floor register. This indicates serious internal problems such as a cracked heat exchanger or other defect. During the life span of any furnace, the metal walls of the heat exchanger may develop a crack or a broken weld, allowing carbon monoxide and moisture-laden exhaust air to circulate throughout the home. If this moisture-laden air condenses inside the ducts it can turn to liquid and obstruct airflow as seemed to be the case here. There was no air flow at one of the heat registers (see photos and videos). This is a high priority concern and should be followed-up by a licensed HVAC technician for repair or replacement as needed. Be advised that if the heat exchanger has failed, the only reliable cure is replacement of the furnace.

- Inaccessible. (See Notes at Heat/AC: Heater Condition)

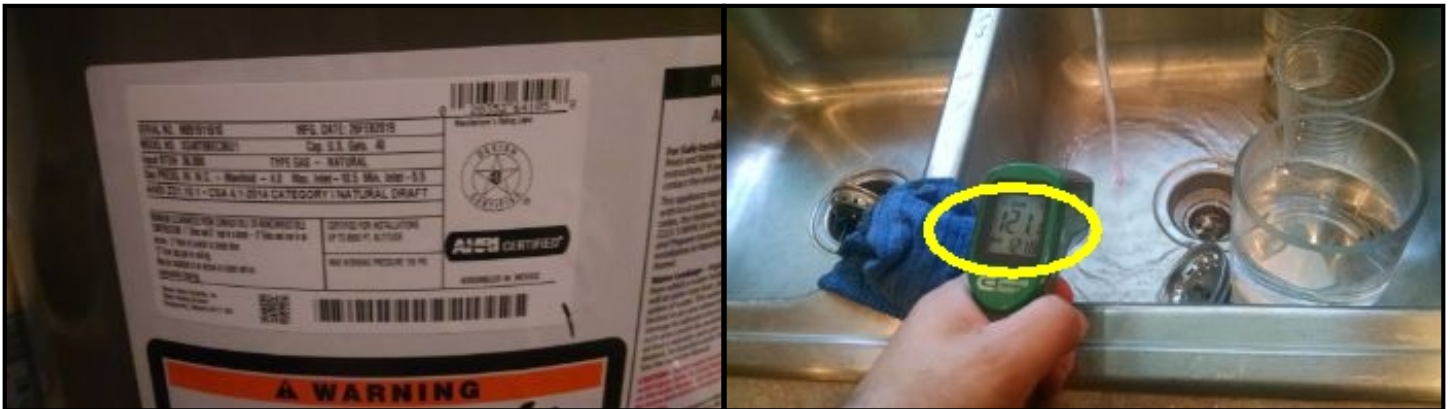
- SATISFACTORY:
- No major system functional concerns noted at the time of the inspection. According to the data plate, this unit was manufactured in Feb 2019 (new).
- Water temperature observed to be: 121 degrees Fahrenheit. This is satisfactory. The generally accepted safe water temperature is one hundred twenty degrees Fahrenheit (120 F) to prevent scalding.

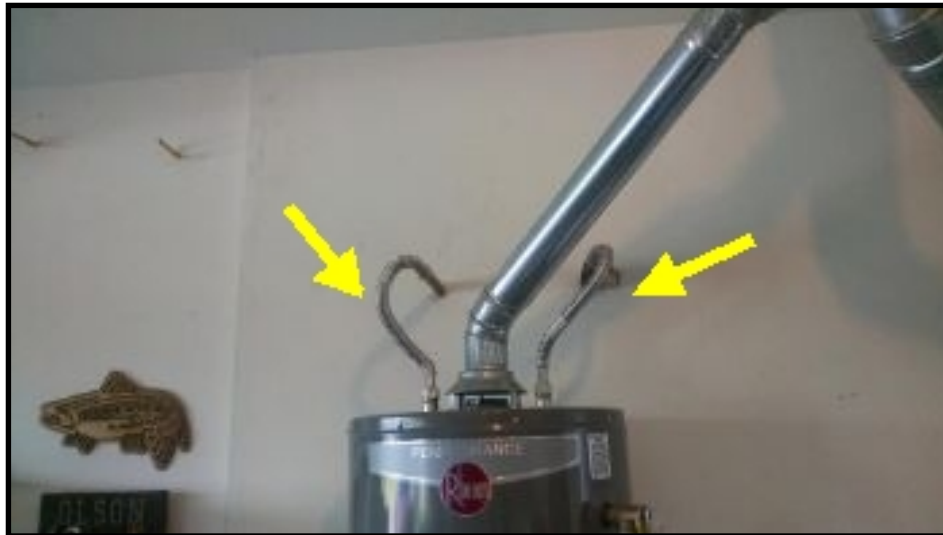
- SATISFACTORY:
- The visible portions of the supply piping appeared to be functional and in satisfactory condition.
- RECOMMENDED UPGRADE:
- The water supply lines were not insulated. We recommend insulating pipes in unheated areas.

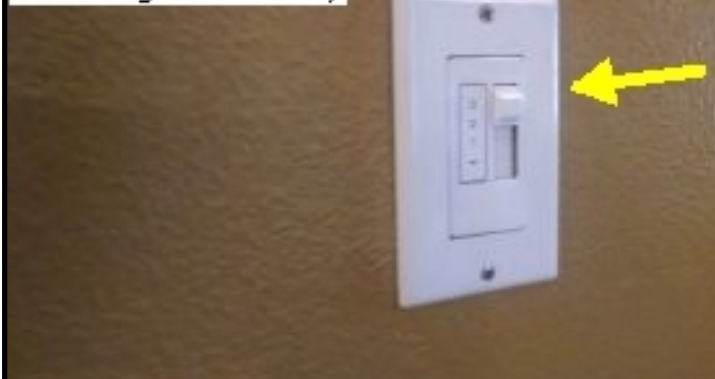
- REPAIR/REPLACE:
- The ceiling fan did not operate properly in the highest speed setting when tested (see short video). We recommend repair or replacement as needed to restore proper function.

Top setting appeared to "underperform" and moved very slowly (possibly only due to existing momentum)

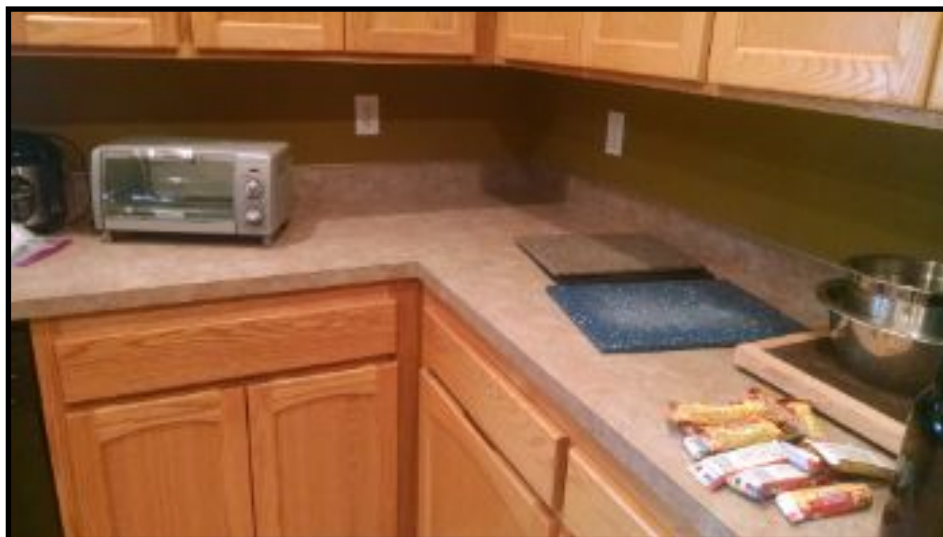
- Plastic laminate tops noted.
- SATISFACTORY:
- There was normal wear noted for the age of the counter tops.

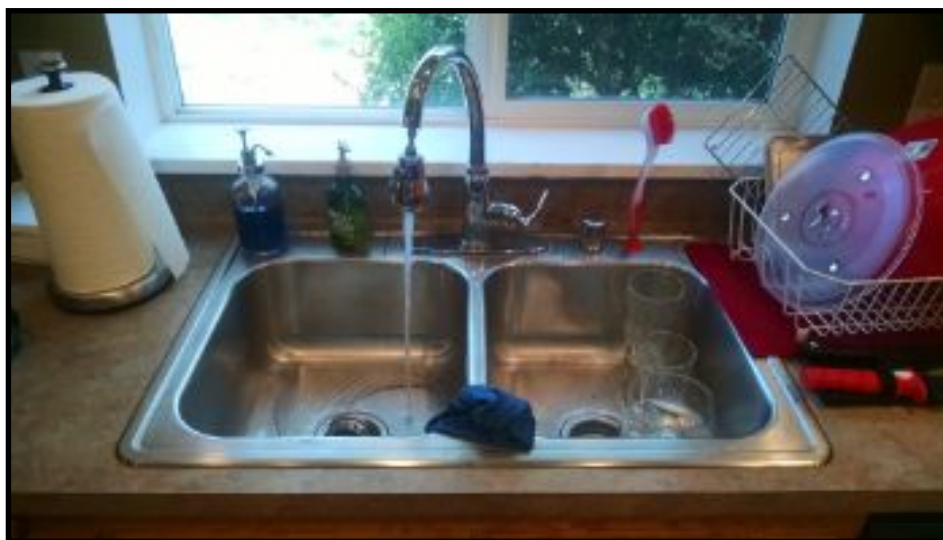
- ****DRAINS****
- **SATISFACTORY:**
- The kitchen sink was in satisfactory condition at the time of the inspection with functional flow.
- ****SUPPLY****
- **SATISFACTORY:**
- Operated normally, at time of inspection with adequate pressure and functional flow.

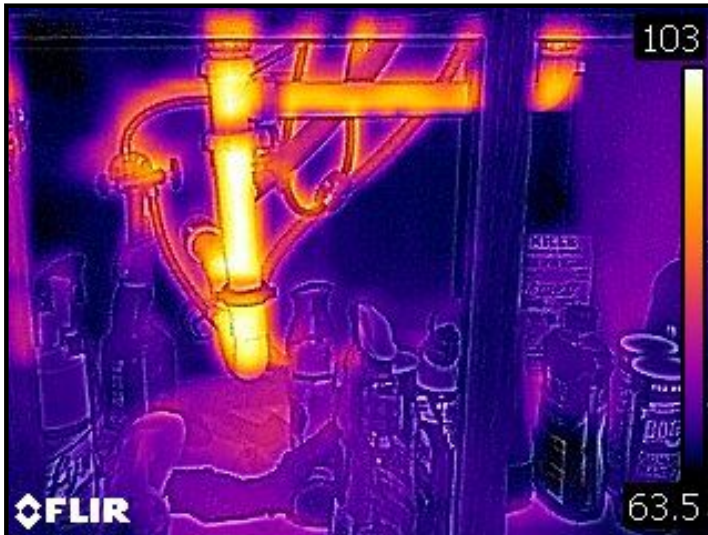
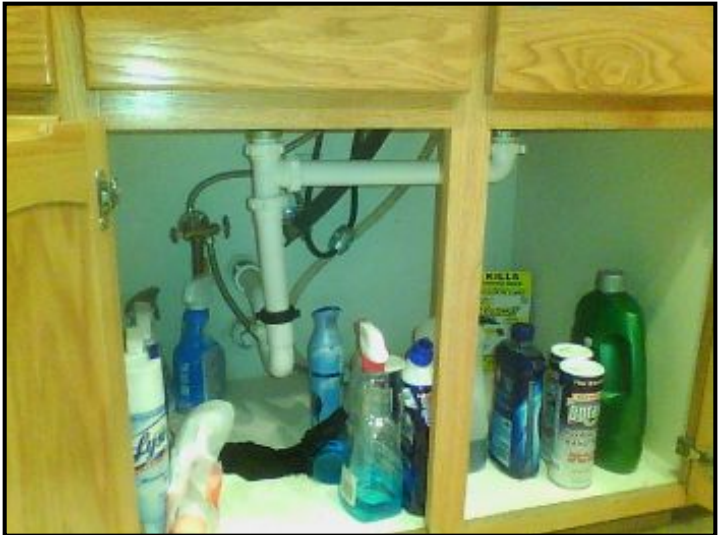
- Limited review due to personal property stored in undersink cabinet.
- **SATISFACTORY:**
- Plumbing appeared in satisfactory condition with no deficiencies observed at the time of the inspection.
- A good faith effort was made to identify leaks using infrared thermography with none observed at the time of the inspection.

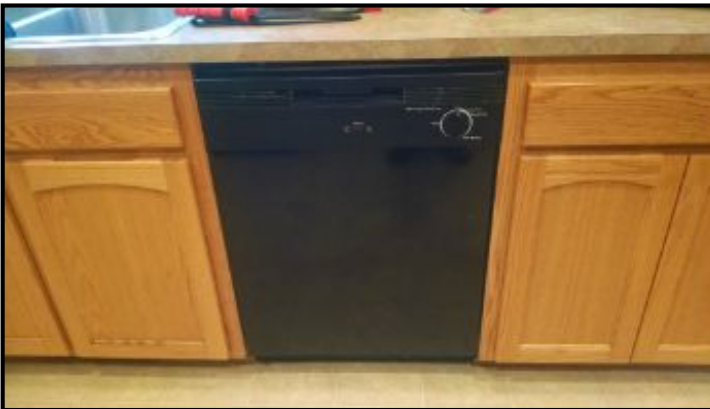
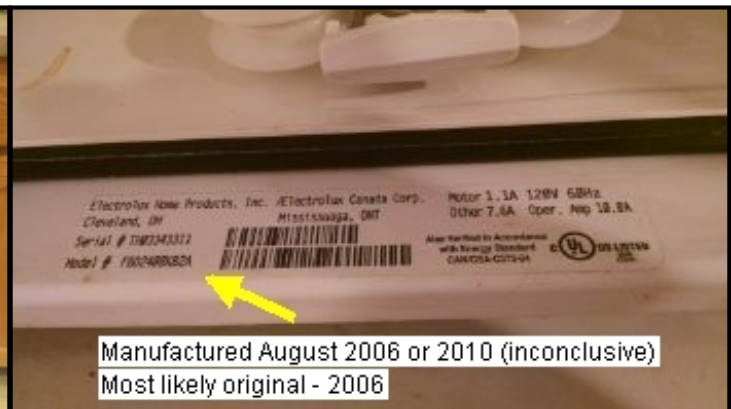
- According to the serial number, this unit was manufactured in 2006 or 2010 (inconclusive). Although functional, we recommend monitoring for performance and budgeting for future replacement as this unit may be nearing the end of its expected service life.

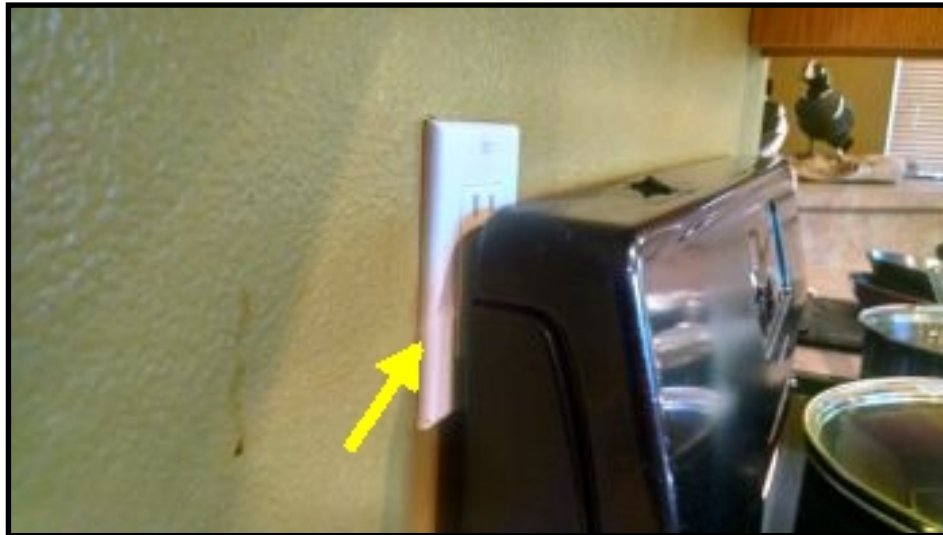
- GFCI outlet(s) that were tested were operational. The GFCI receptacle behind the stove was obstructed by the appliance panel and not tested.

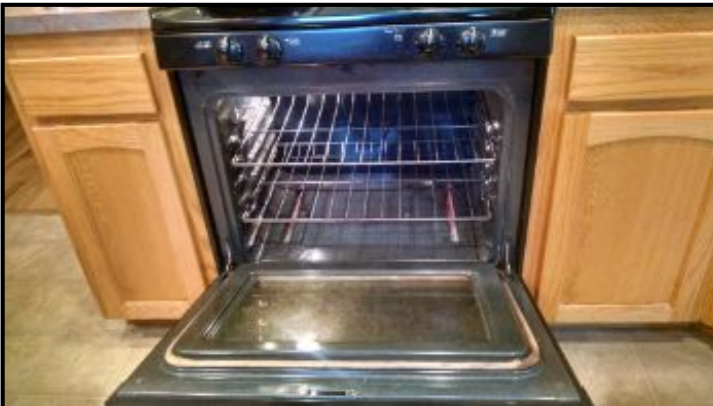
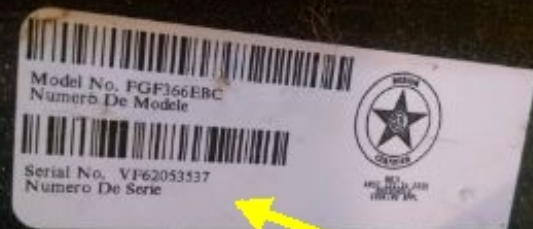
- Oven: gas burners
- MONITOR:
- According to the serial number, this unit was manufactured in 2006 (original) making it 13 years old and functioning beyond its expected service life. Although functional, we recommend monitoring for performance and budgeting for future replacement as units of this age can fail at anytime.

Manufactured May 2006 (original unit)

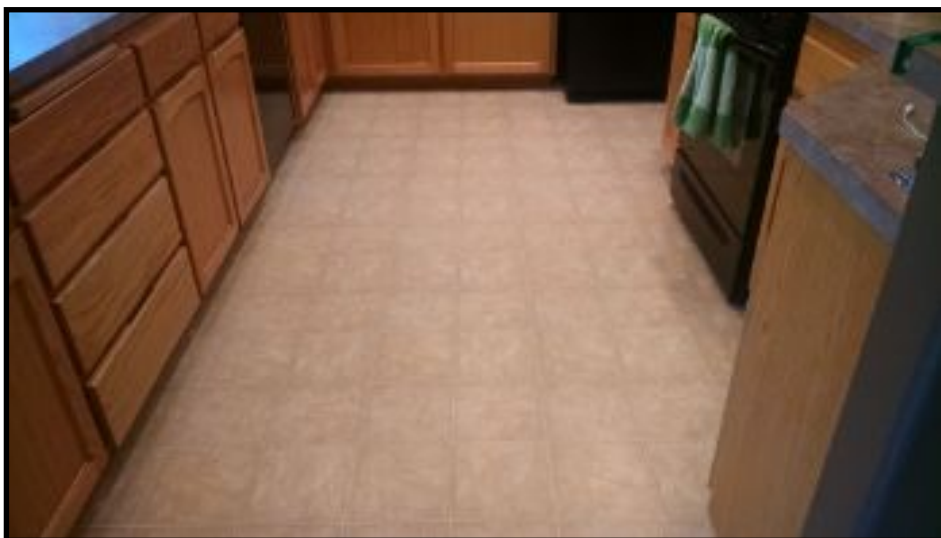
- SATISFACTORY:
- Visible portions of the floor coverings showed normal wear for their age.

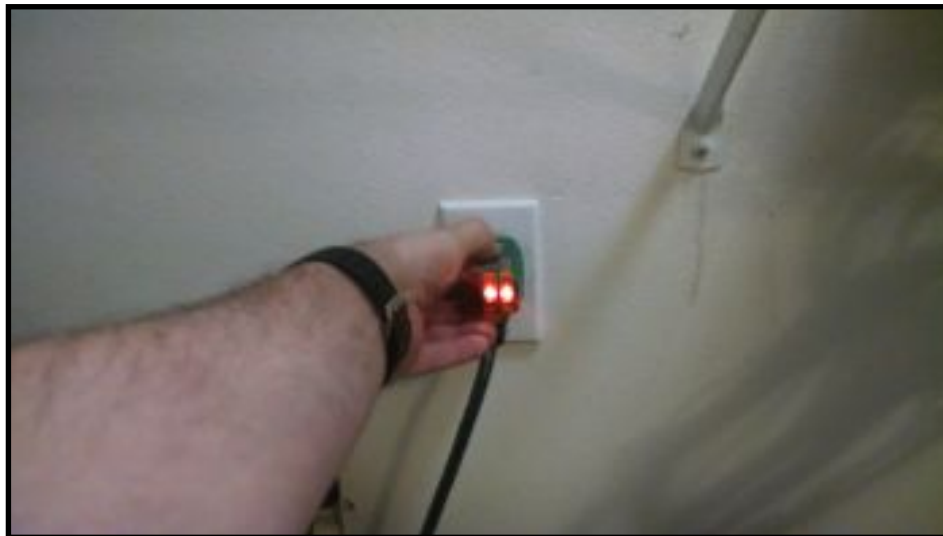
- RECOMMENDED UPGRADE:
- GFCI protected receptacles may not have been required in the laundry area when the house was built (not required until 2012). We recommend upgrading with GFCI's at all receptacles near water sources.

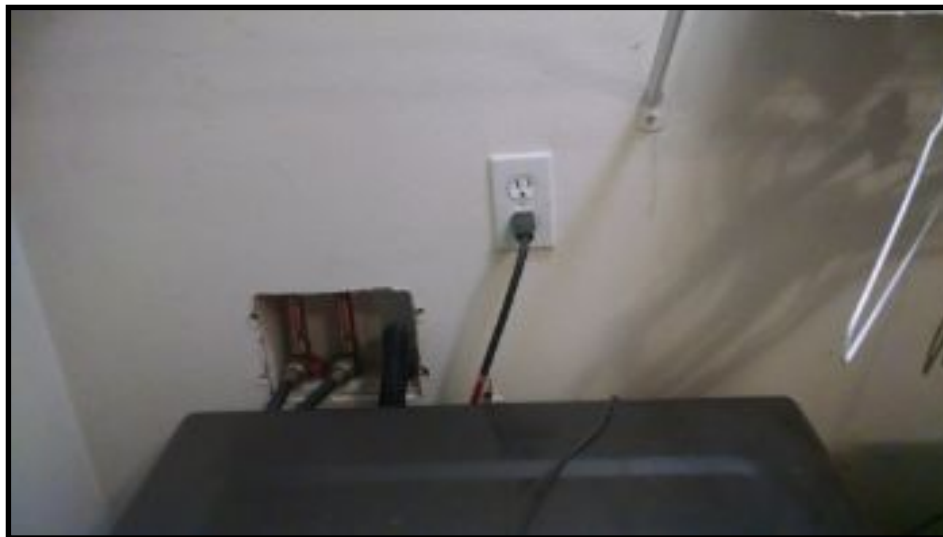
- The visible portions of the washer/dryer water valves and drain (standpipe) appeared functionally adequate. They were mostly concealed inside the wall and not fully visible.
- SATISFACTORY:
- Limited visible plumbing components appeared functional at the time of the inspection.

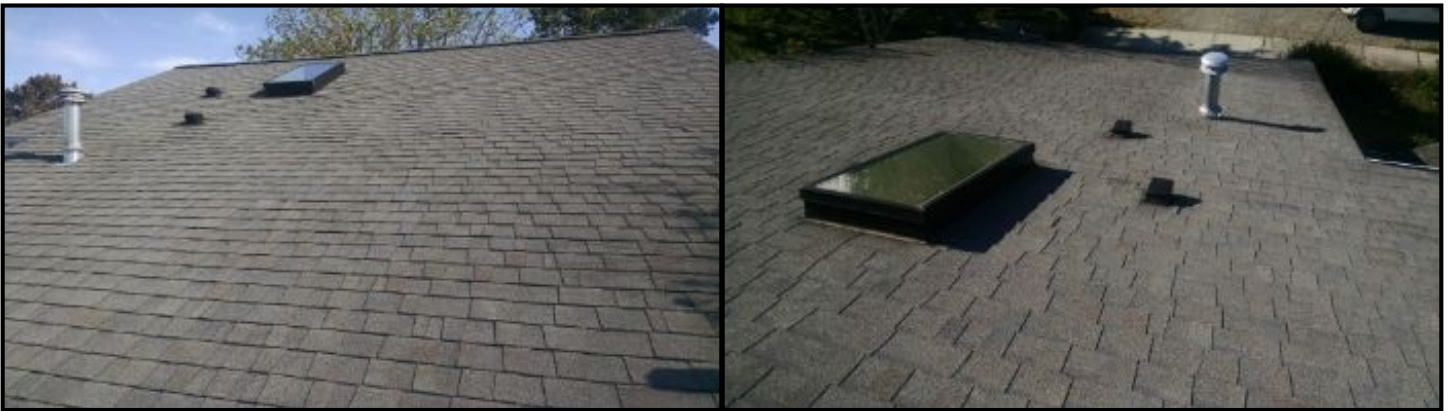
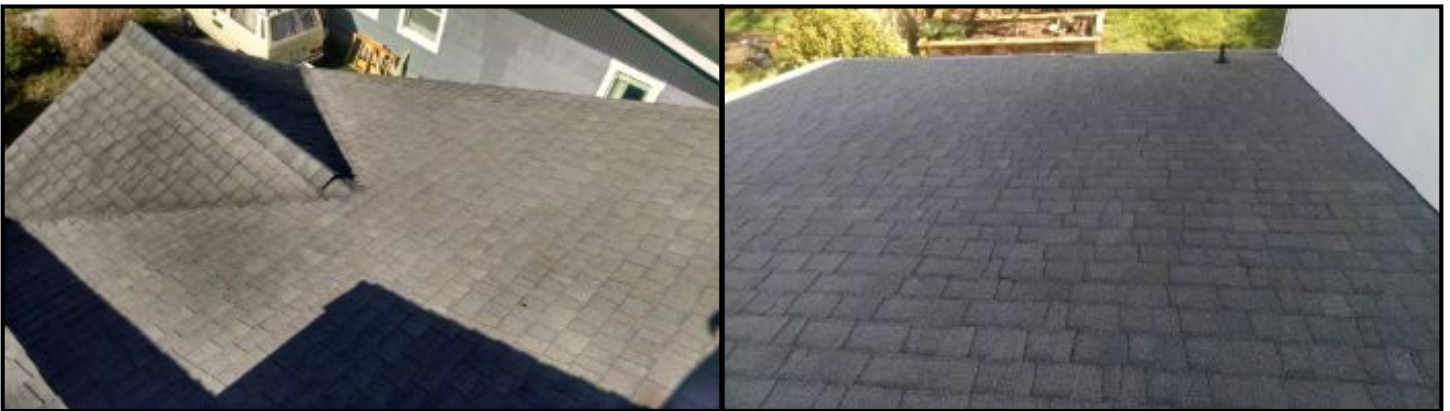
- The roof covering materials appeared to be in serviceable condition at the time of the inspection.
- Maintenance Tip: Moss on the roof can lead to the premature failure of the roof and subsequent leaks. We recommend treating moss during its growing season (wet months) with a moss killer. For information on various moss treatment products and their pros and cons, visit <http://bryophytes.science.oregonstate.edu/page24.htm>. We recommend avoiding pressure washing composition/asphalt shingles as this can artificially age the roof.

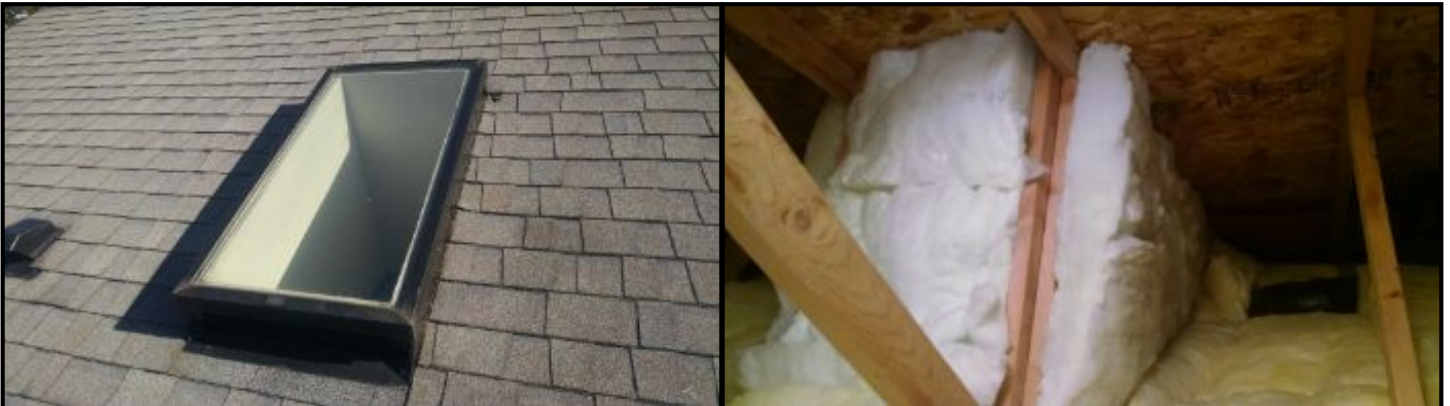
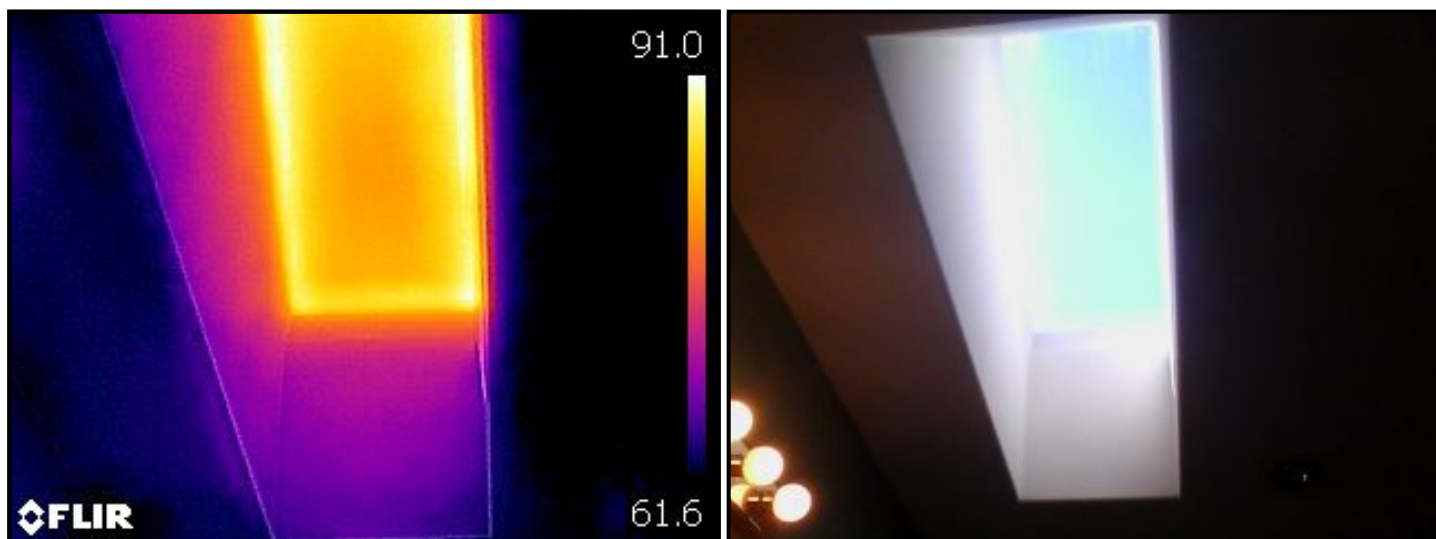
- No signs of leaking around the skylight were observed at the time of the inspection.
- A good faith effort was made to identify leaks at the skylight from both above and below with none found.
- A "water shed test" (simulated rain using a hose) is beyond the scope of a home inspection. No warranty of future performance of the skylights is offered or implied.

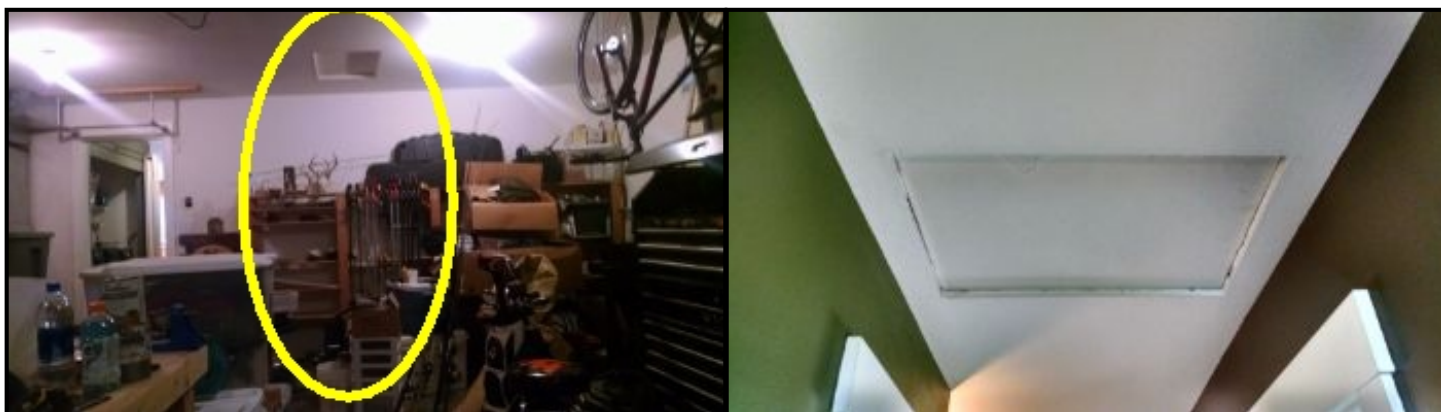
- ****Location of access****
- Scuttle Holes located in:
 - Hallway ceiling.
 - Garage ceiling.
- ****Access Observations****
- Limited review. The garage attic was inaccessible due to obstruction below by a large volume of stored items.
- **SATISFACTORY:**
- Upstairs attic access appeared functional with batt insulation over the hatch door.

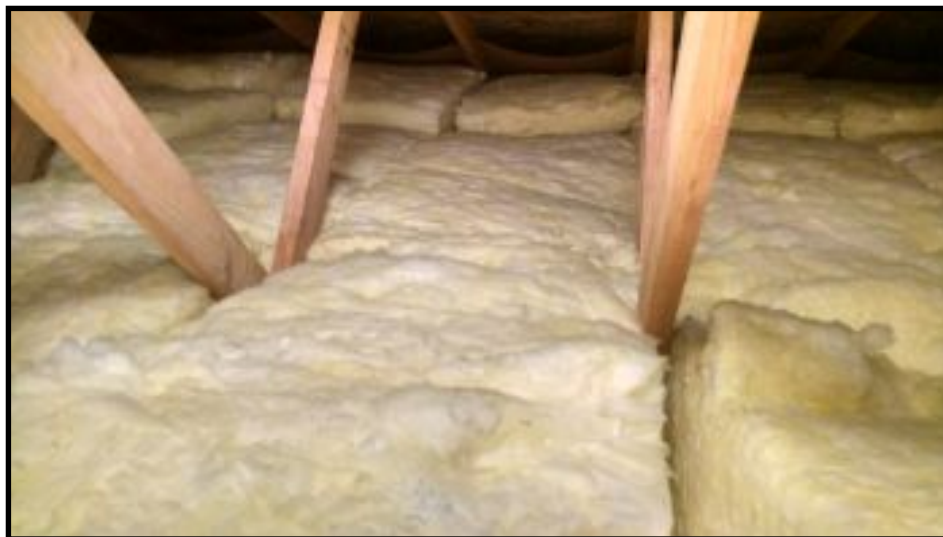
- **SATISFACTORY:**
- Insulation appears adequate and in satisfactory condition.
- Insulation level in the attic is typical for homes this age.

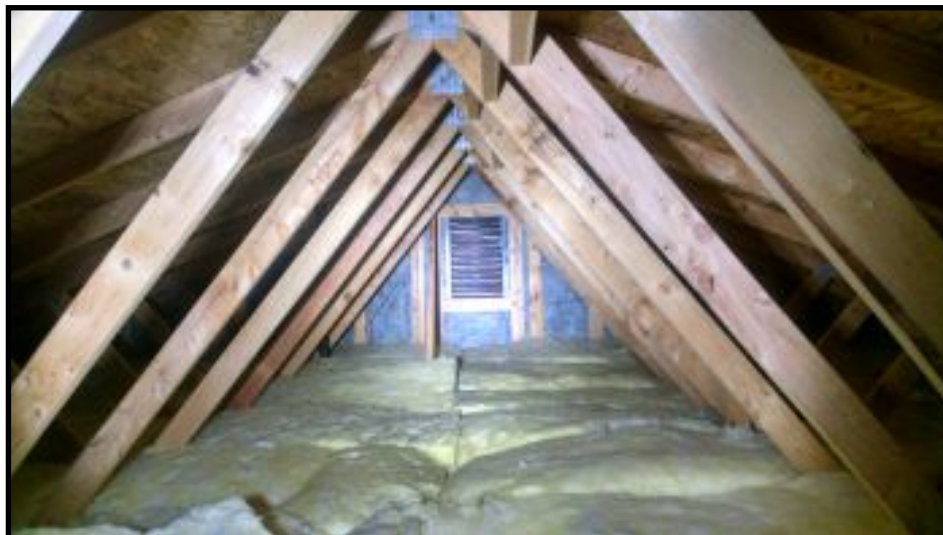
- Limited review due to insulation installed between the trusses.
- SATISFACTORY:
- Visible portions of the attic structural members appeared to be functionally adequate at the time of the inspection.

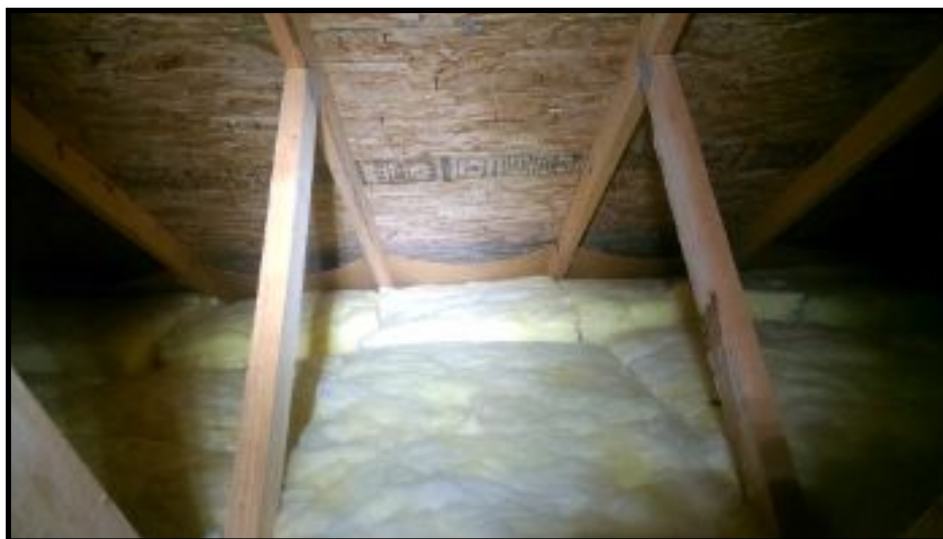
- SATISFACTORY:
- Vent screens noted as functionally adequate.
- Cardboard baffles to ensure good air flow through soffit vents noted as present and functional.

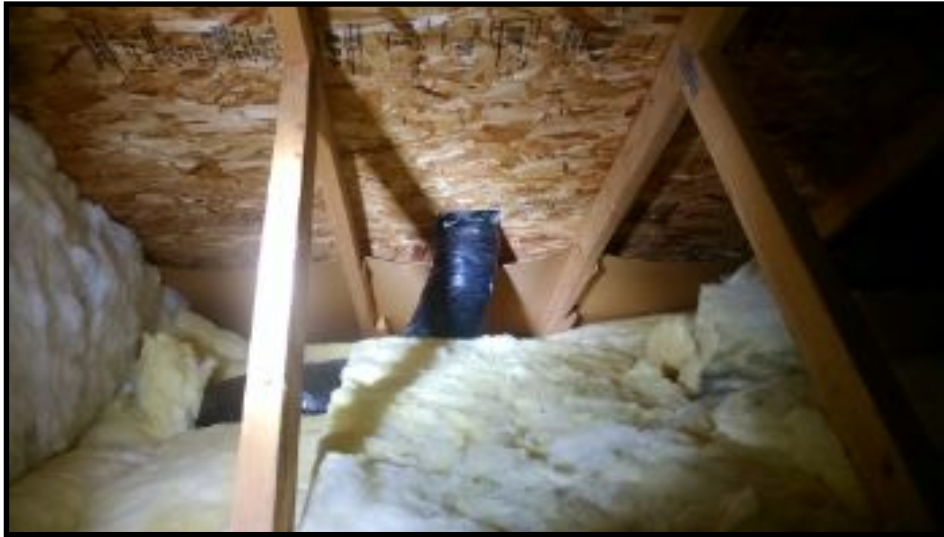
- SATISFACTORY:
- Functional with no deficiencies or safety concerns noted at the time of the inspection.

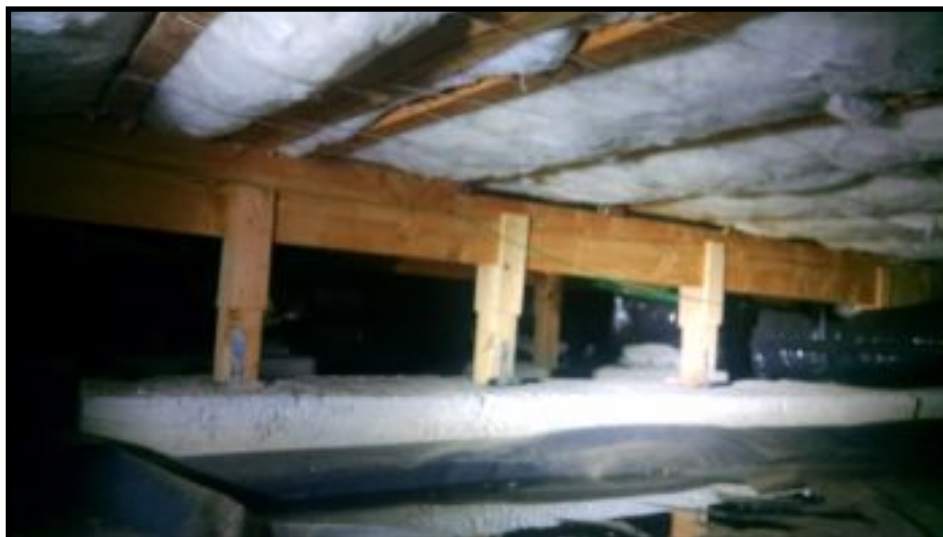
- Vertical Support Material: Wood posts on poured concrete piers
- Horizontal Beam Material: Wood girder beams
- SATISFACTORY:
- Foundation posts and beams appeared to be functionally adequate.

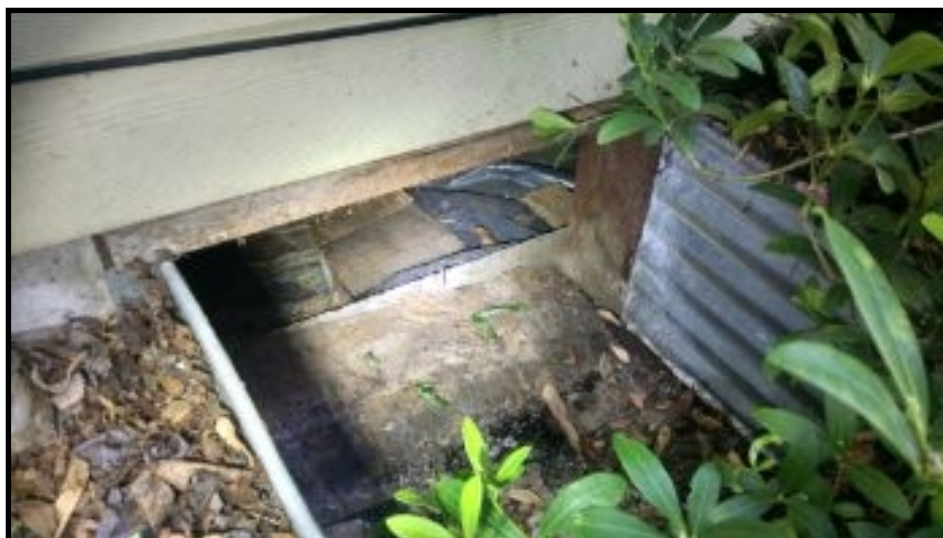
- SATISFACTORY:
- Exterior entrance was in serviceable condition.

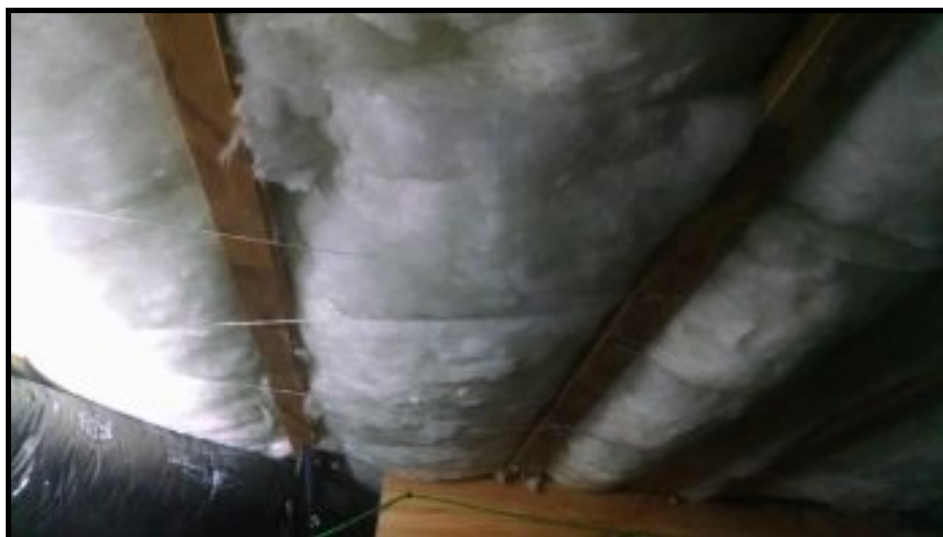
- SATISFACTORY:
- Insulation appeared satisfactory at the time of the inspection.

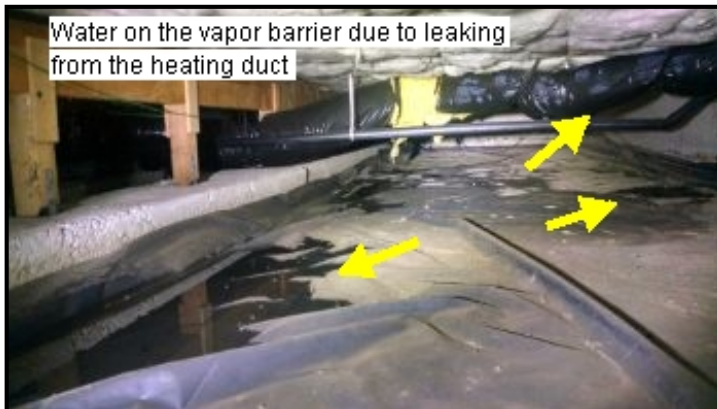
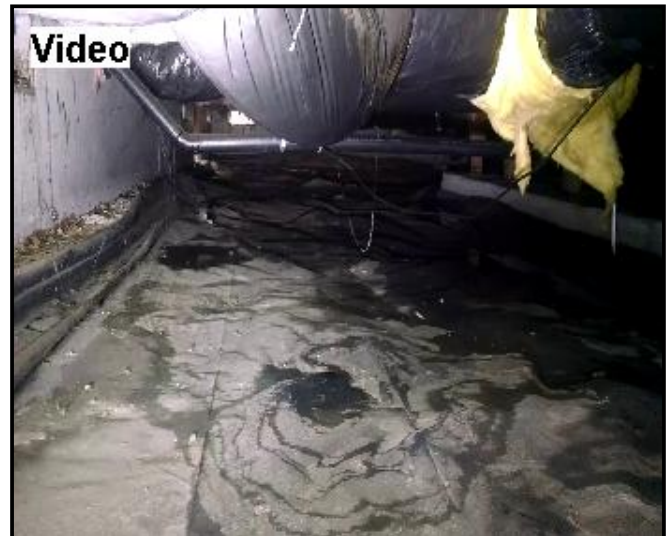
- FURTHER EVALUATION:
- Some of the subfloor ducts were saturated with water due to a problem with the furnace (See HVAC section for more) and may need to be replaced.
